POWER HOUSE (604)  
HABS No. NY-5708-24

Built: 1905-1909  
Architect: Cram, Goodhue and Ferguson

CULLUM HALL (605)  
HABS No. NY-5708-42

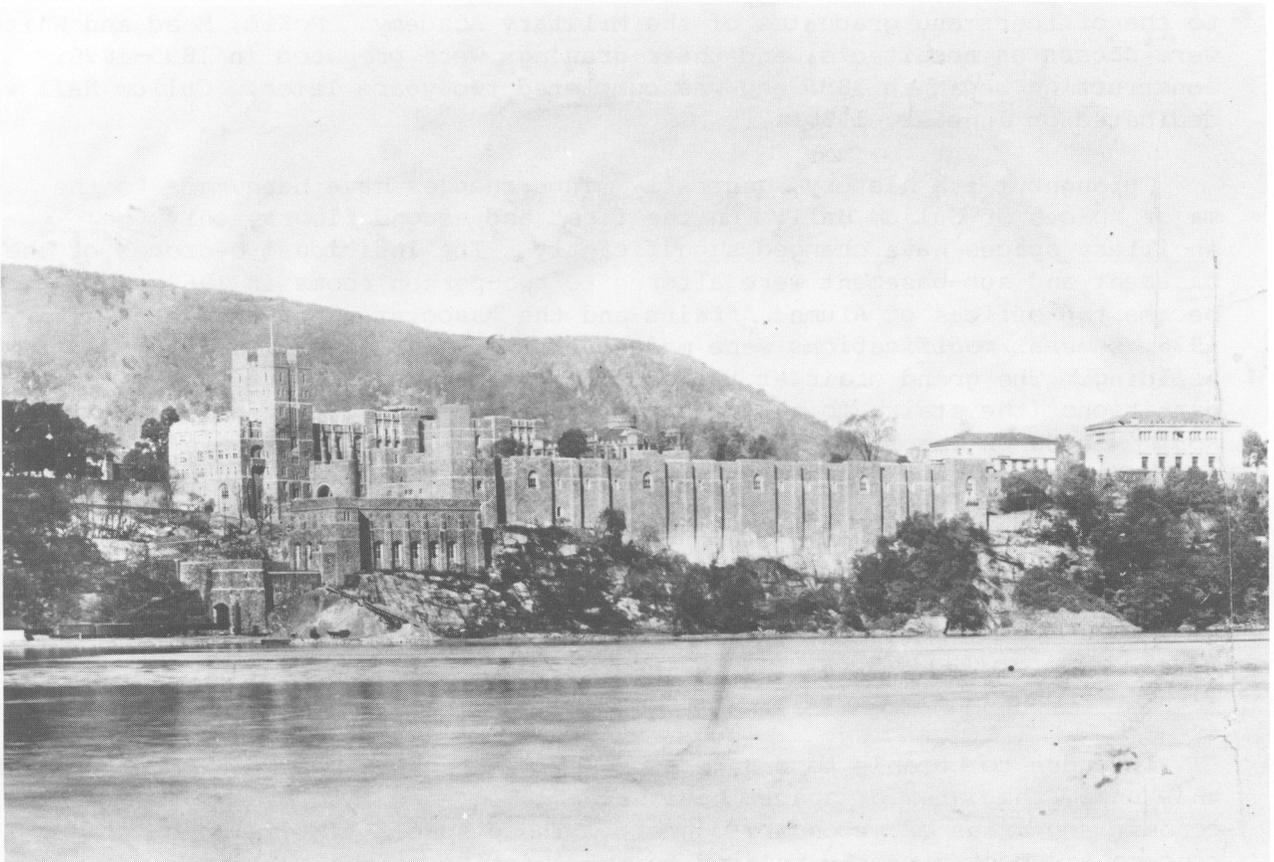
Pl. 604-a  
Stockbridge Collection, neg. #955  
USMA Archives

Coupled with Thayer Hall, Mahan Hall and the Administration Building, the Power House presents an impressive sight from the river and from across the river (Pl. 604-a). This is the view of the structure that is the most important. The metal buildings, concrete block sheds, building supplies, etc., located along the shore below the Power House create a visual clutter that distracts from the visual cohesiveness of this area. Consideration should be given to relocating such features to more remote areas and to maintaining a more park-like setting along the entire length of the river bank.

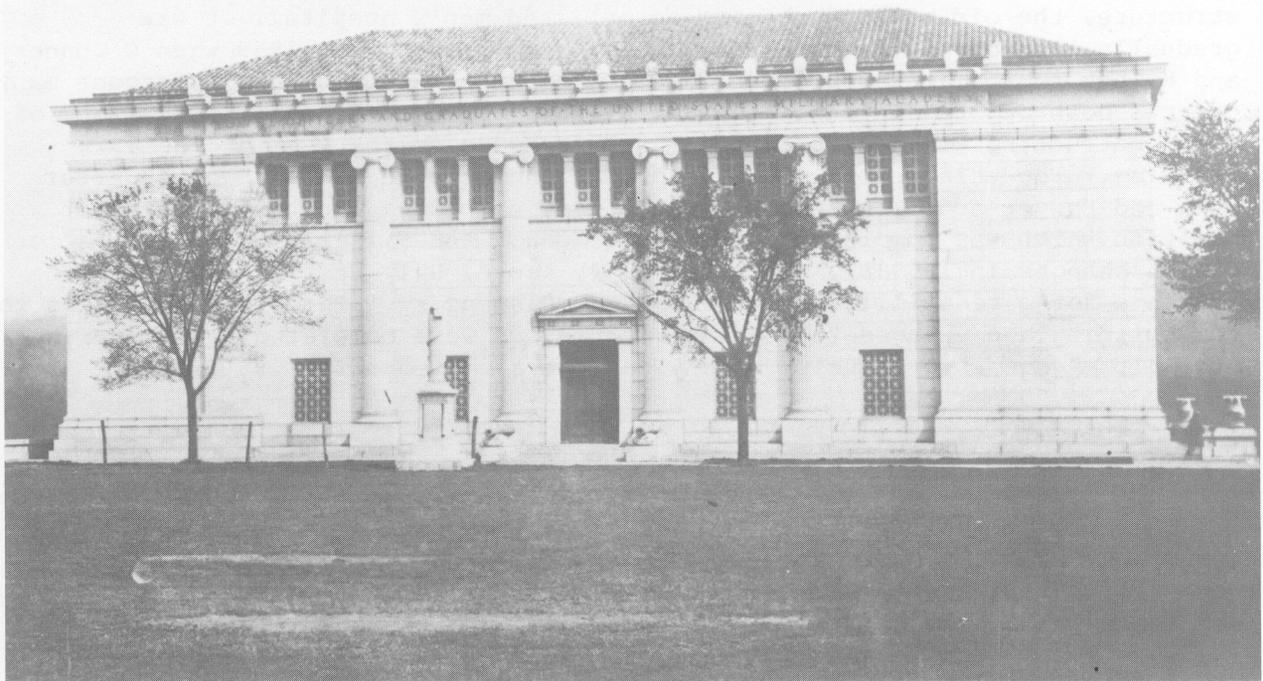
Pl. 605-e: 1909  
Stockbridge Collection, neg. #669  
USMA Archives

Of primary concern on the exterior of Cullum Hall is the roofing material. When completed, the roof was covered with green, barrel-shaped clay tile (Pl. 605-e). This has since been replaced with a standing seam material. Though the vertical seams mimic the vertical ridges of the tile, the change, nevertheless, affects the visual perception of the building. The existing covering is inappropriate and should be replaced with tiles similar to the original.

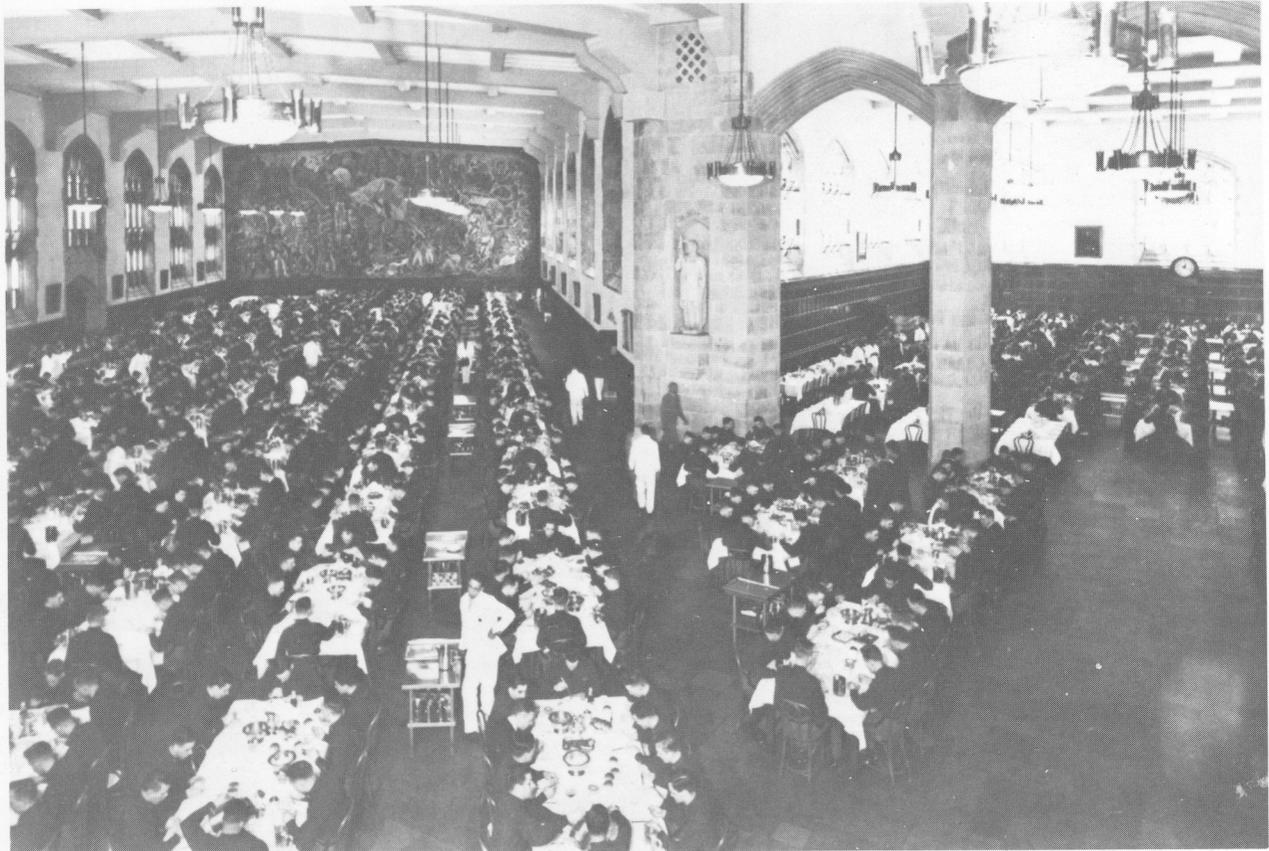
Pl. 745-c: after 1946  
USMA Archives

With each addition to the dining hall, interior details were either copied from the original or reinterpreted in such a manner as to create an overall harmony (Pl. 745-c). The sensitivity with which the remaining portion of the 1926 facade has been treated is, in itself, remarkable considering the state of the art in historic preservation during the 1960s. The overall character of the dining hall has been firmly established; continued preservation maintenance is required. The Exhibition Hall (Pl. 745-d) and corridor of the fifth floor have also survived the various additions to Washington Hall. The maintenance of its architectural character is recommended.

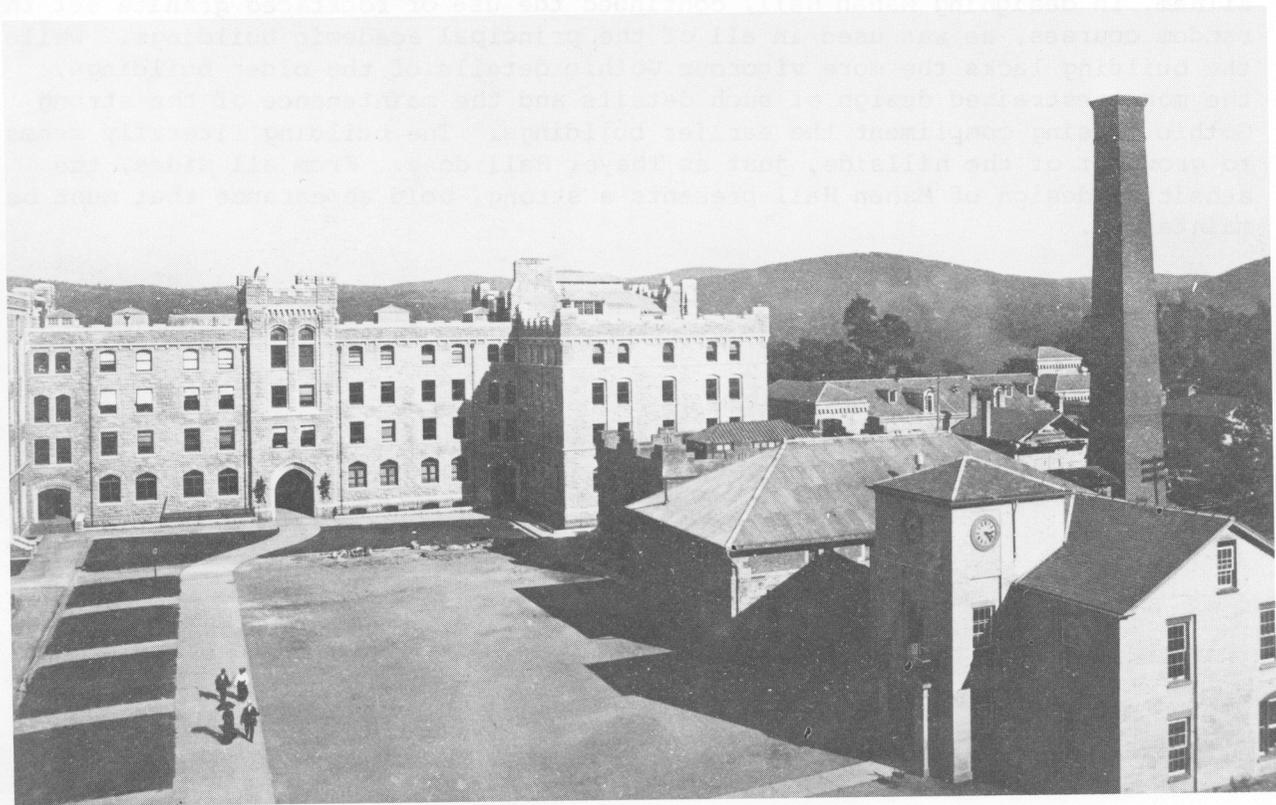
Pl. 751-b: 1902-1910  
Stockbridge Collection, neg. #17  
USMA Archives

No less important is the west facade (Pl. 751-b). The courtyard created by Hunt's academic building and the surrounding barracks is probably the best known of any exterior space at West Point. Rare is the twentieth century Cadet who has not had to "walk the area". It should also be preserved.
